## THE RESTORATION OF THE HELLENISTIC FOUNTAIN OF SAGALASSOS IN TURKEY

Teresa Cristina Patrício

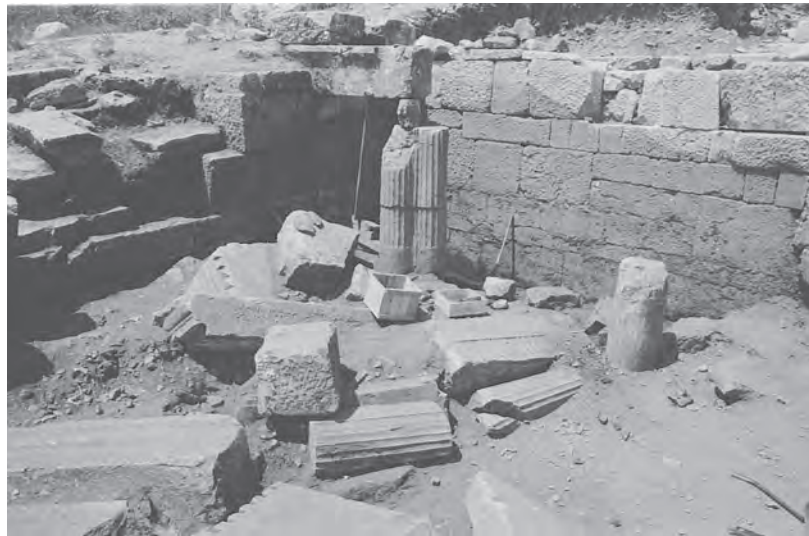
Figure 2 - General view during the excavations, July 1992.

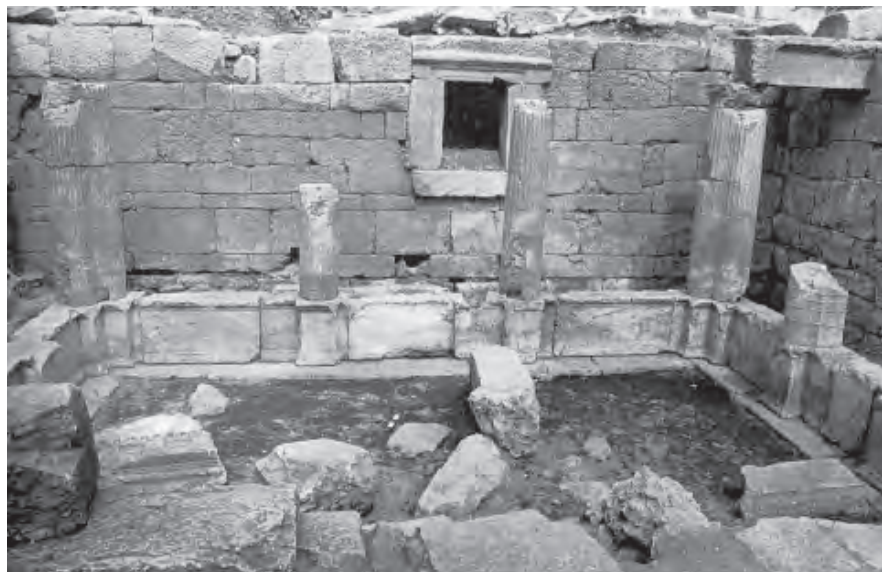
Figure 3 - General view before the restoration works, August 1993.

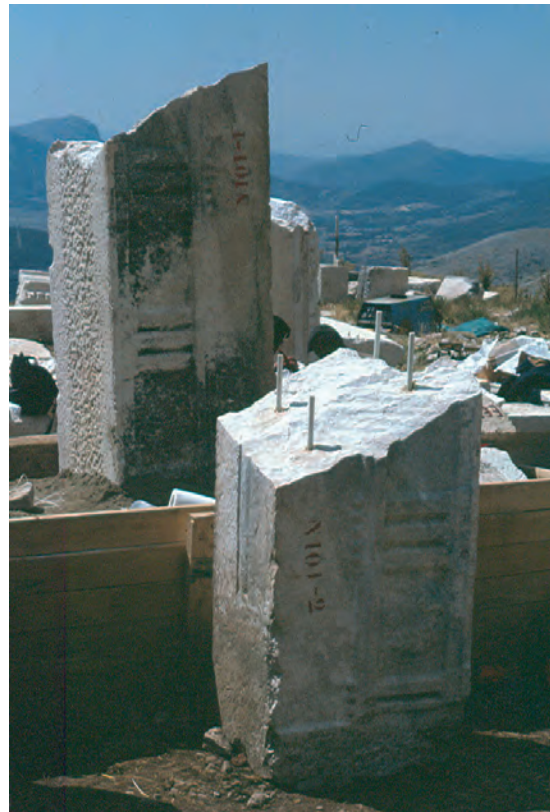
Figure 9 – For joining the architraves, fibreglass rods were used together with the epoxy adhesive.

For joining the structurally important broken blocks, such as columns drums, architraves and cornices, fibreglass rods were used together with the epoxy adhesive. Two conditions were imposed on this work. First, the broken blocks should be joined in such a way that the strength of the joined block would not exceed the limit state strength of the monolithic block. Second, if the joined block were to break, it should break again in the original failure. To fulfil these requirements, the application area of the epoxy glue was limited to only half of the broken surface and the Fibreglas reinforcing rods were designed appropriately according to these considerations. The brittle nature of the fibreglass is an advantage here, as it means that the reconstruction can be altered at any time in the future, as the broken reinforcement can be removed and replaced by a similar system. The number, size and length of the reinforcing rods varied according to the broken parts of the block and its structural function. For the blocks under flexural stress, like architraves and cornices, the rods should have a certain anchorage length, so that they would not be pulled out. Generally 4 fibreglass rods of 34 cm length and 16 mm diameter were used for joining these blocks (Figure 8). Shorter rods are sufficient for joining the column drums, as the main structural stress on them would be in shear. Generally 4 fibreglass rods of 20 cm length and 12 mm diameter were used to join the columns drums.

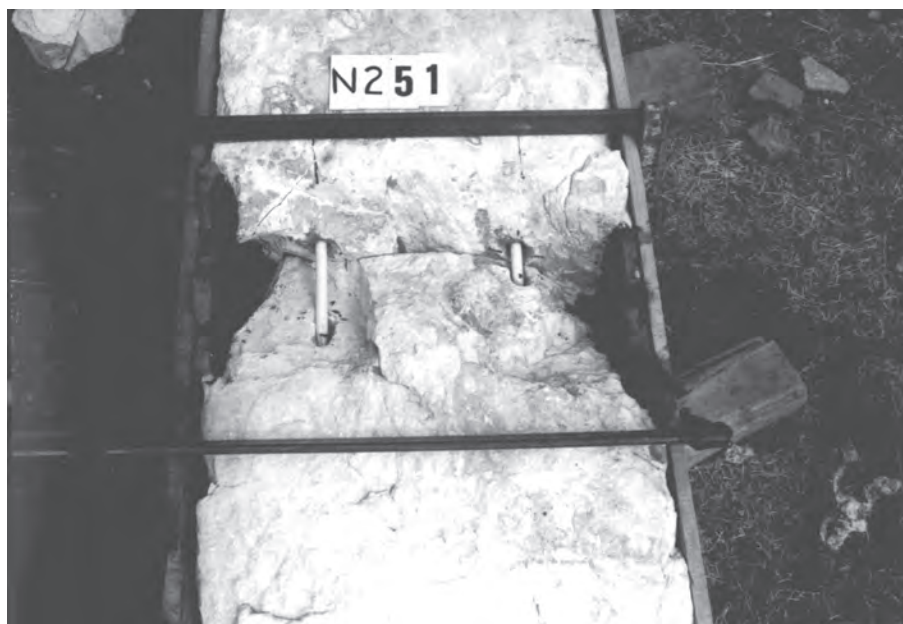
Figure 10 – View of a joined cornice block, before the missing parts were completed. The fibreglass rods used for joining the two fragments are visible.

The epoxy mortar was applied in a few layers, where each layer was compacted firmly. According to the volume to fill and the structural function of the block to be completed, fibreglass bars were sometimes used for a stronger bond between the epoxy mortar and the stone blocks (Figure 10, Figure 11). As epoxy mortars discolour under ultraviolet radiation and in order to create a proper surface texture, a 1 to 2 cm thick covering mortar was applied over the dried epoxy fillings (Figure 12). The covering mortar was a zinc chloride-based mineral mortar, which was also tested in laboratory before being used. This quick setting and non-shrinking covering mortar has a very similar colour to the stone and its shape and textures can be finished easily by carving (Figure 15).

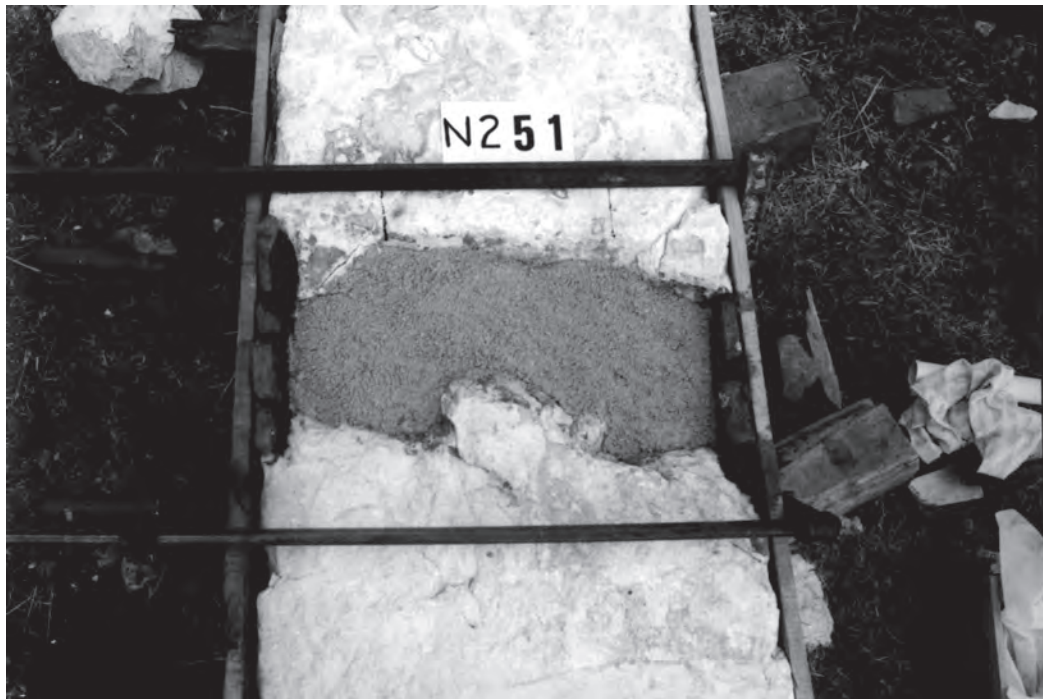
Figure 11 – View of the cornice block after its missing parts were completed by an epoxy mortar. The epoxy mortar will then be covered by the final covering mortar.

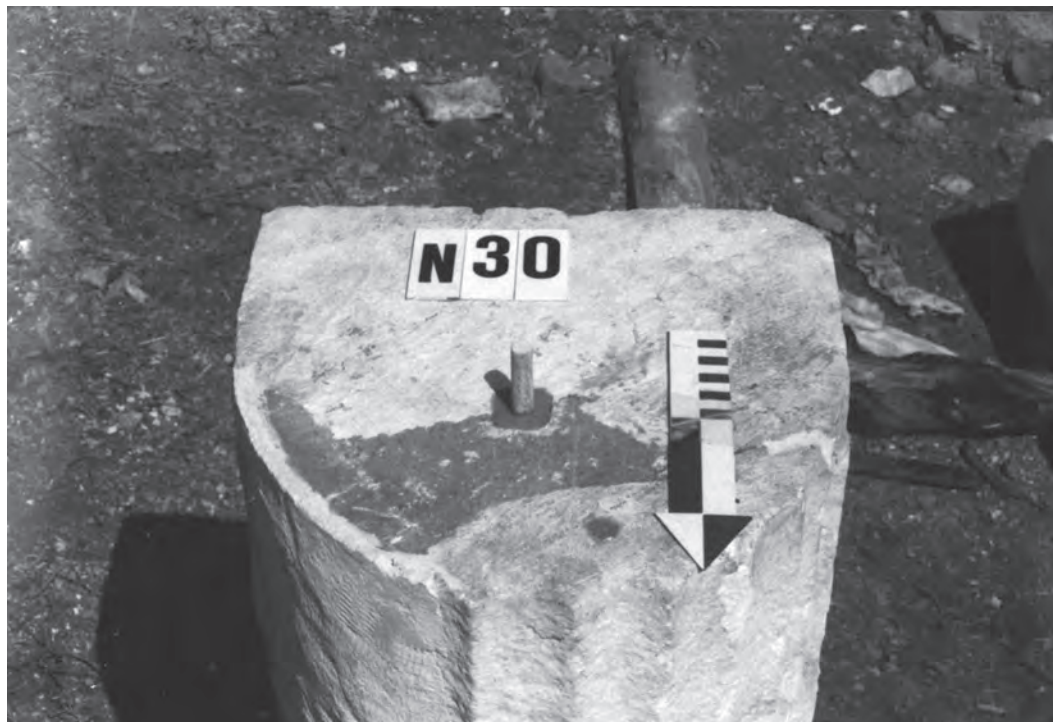
Figure 12 – View of a restored column drum. The filling and the covering mortar are visible as well as the fibreglass rod for the vertical connexion of the drum.

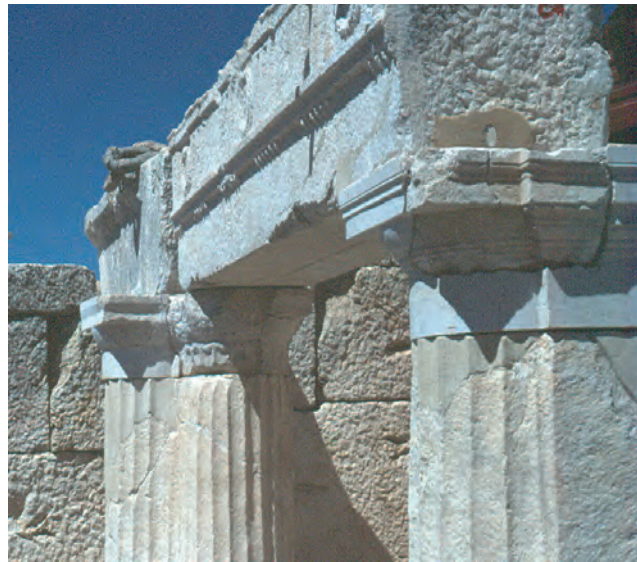
Figure 15 – The original small fragments integrated into the new carved blocks. The final decorations as well as matching the integrated original fragments were further finished.

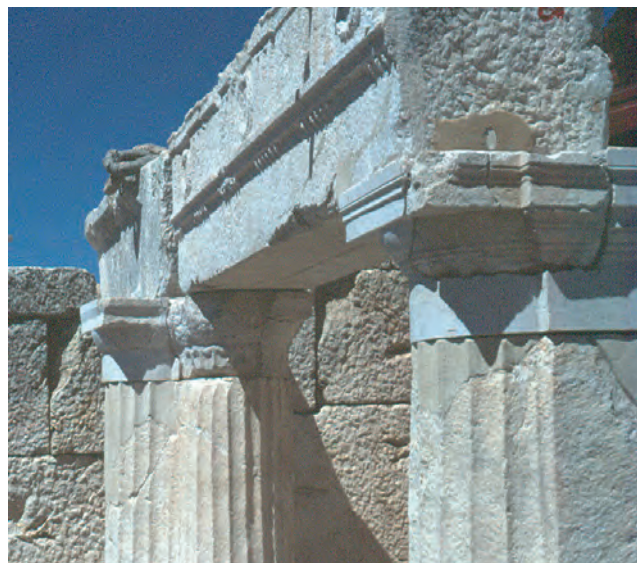
Figure 16 – Final surface carving of the integrations after their final anastylosis.

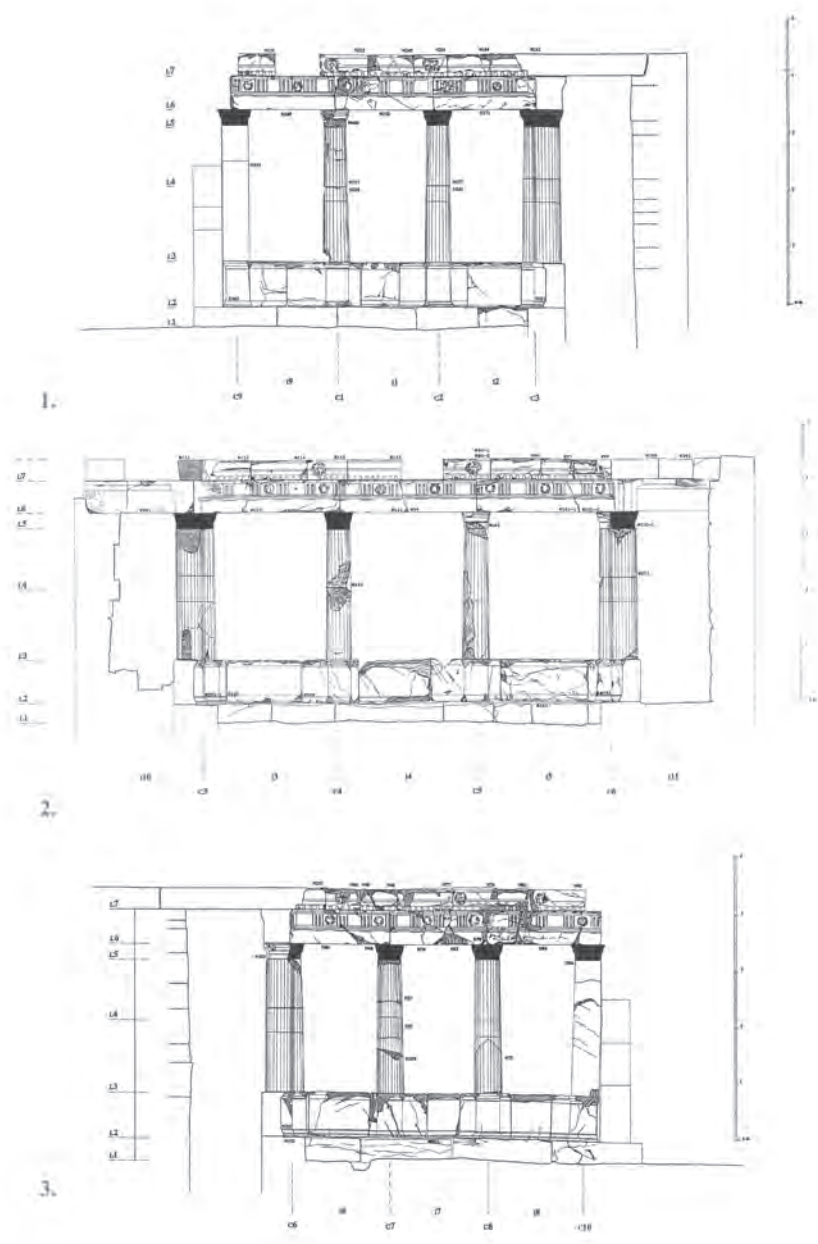
Figure 18 - Second level of anastylosis, introducing the new carved capital.
