Cais das Colunas' pre-deconstruction (1997) diagnosis

CAIS DAS COLUNAS' PRE-DECONSTRUCTION (1997) DIAGNOSIS

Alexandra de Carvalho Antunes

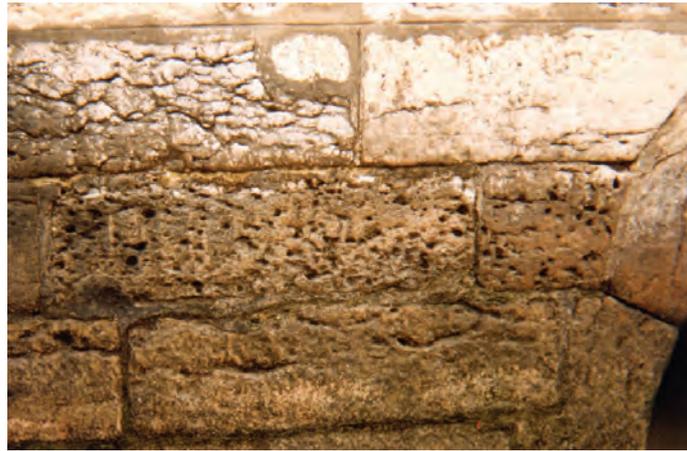
Figure 5 - Cais das Colunas, 1996. ACA®

The Map II (Figure 6) registers concretion, from biological origin, and variations of erosion, like erosion of edges and vertices, alveolization or alveolar weathering. The last ones occur due to the rocks' structural and compositional heterogeneity (Figure 5).

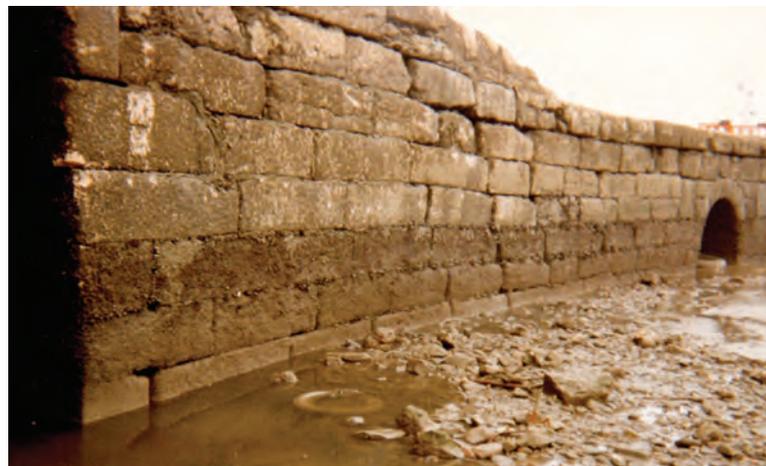
Figure 8 - Cais das Colunas, 1996. ACA®

The Map IV (Figure 10) registers chromic alteration of the surface of the rock (Figure 8), presence of oxidized metallic elements (Figure 9) and pathologies related with mortars. It were mapped the presence of cement mortar at the joints and the lack of mortar (Figure 8). The late one was detected especially at the area subjected to variation of the level of the river water due to tides.
